Figure 1: Management Unit 3A (Leysdown)

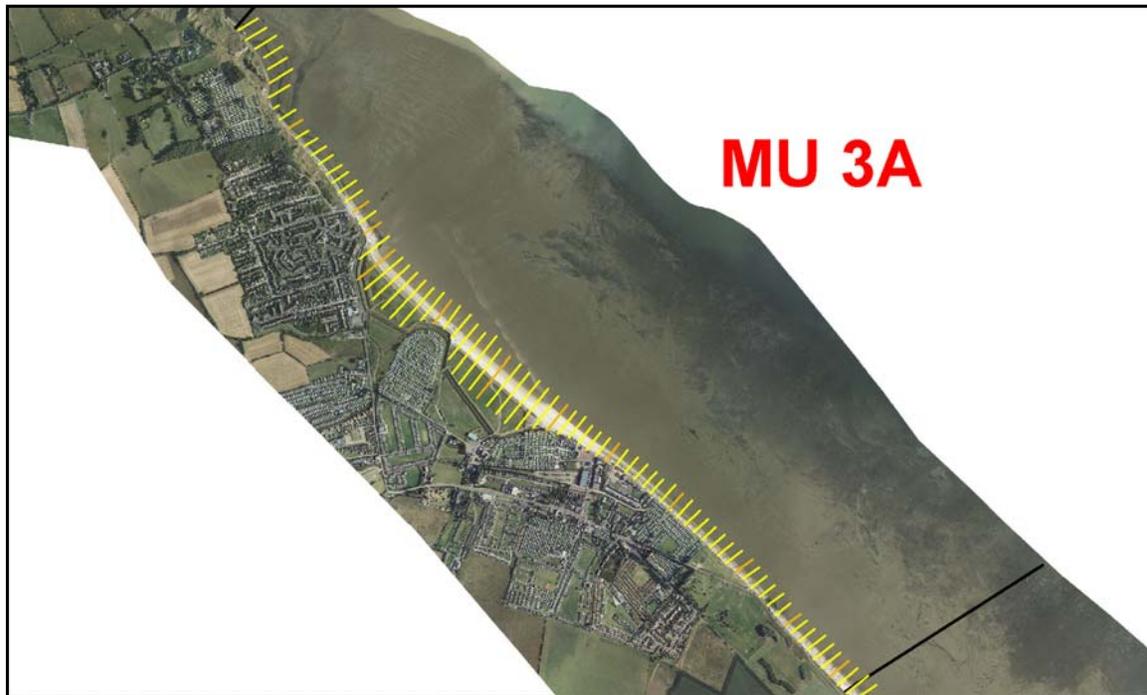
*Blue: Recycling Extraction Point*

*Red: Recycling Deposition Area*

This unit covers the clifftop village of Warden, a low-lying area known as ‘The Bay’ and the low-lying village of Leysdown-on-Sea. Along this section of coast a number of management structures are currently in place. The cliffed section of the Warden village has a toe defence structure, which limits but does not prevent erosion. This structure was upgraded in the summer of 2007 to help maintain some protection of the cliff top assets. The low-lying section of Warden is currently defended by a concrete seawall. At the ‘The Bay’ there is a secondary defence (clay bund), whilst at Leysdown-on-Sea there is a concrete seawall and 25m spaced timber groyne.
