Figure 1: Management Unit 4B (Whitstable)

The beach at Whitstable is a predominantly shingle beach, heavily mixed with fine material due to the capital scheme which took place in 2006. This frontage is heavily groyned, also a result of the capital scheme. The residential town of Whitstable is densely populated and mostly on low lying land behind the beach. The coastal protection and defence works is fundamental within this management unit for the protection of these residential and commercial buildings. A new seawall was constructed during 1953/4 after the 1953 storm which breached the sea wall and flooded the town. Maintenance works have since been completed on the sea wall in the mid 1970s and late 1980s.

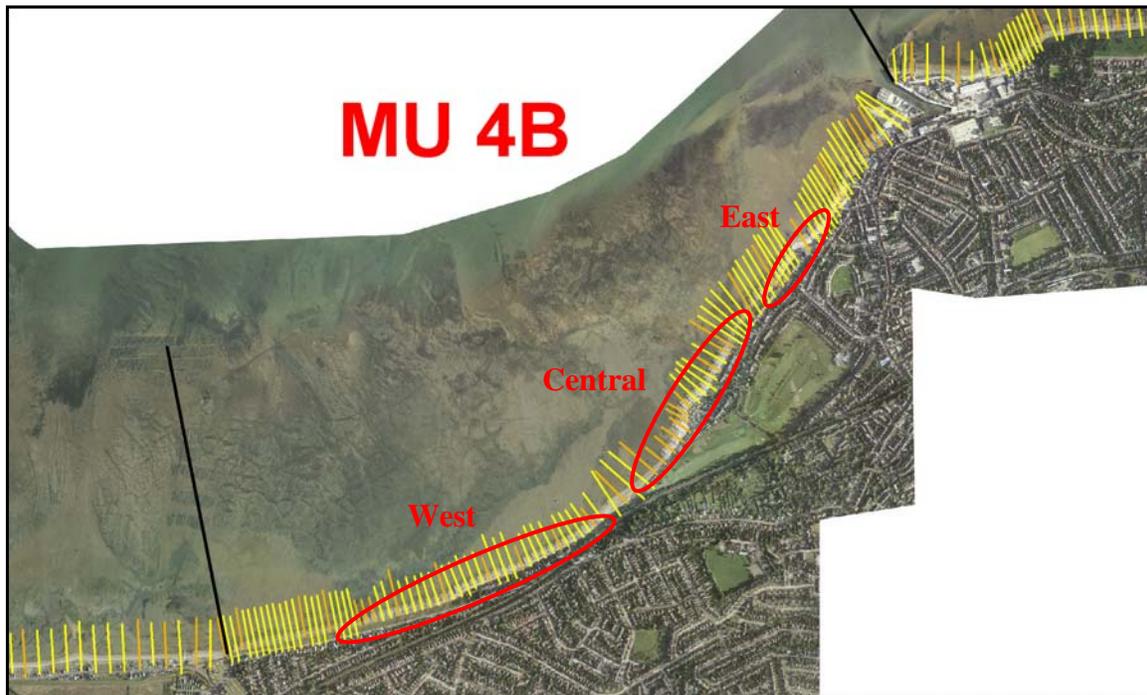
Blue: Recycling Extraction Point
Red: Recycling Deposition Area

The most recent addition to the coastal defence works within this management unit was undertaken during 2006, which increased the material across the unit by 68,000m³. Locations of the deposition sites can be seen in Figure 1. Maintenance will be necessary on the seawall and groynes by 2016 as they will be 10 years old.
