Figure 1: Management Unit 5A (Tankerton)

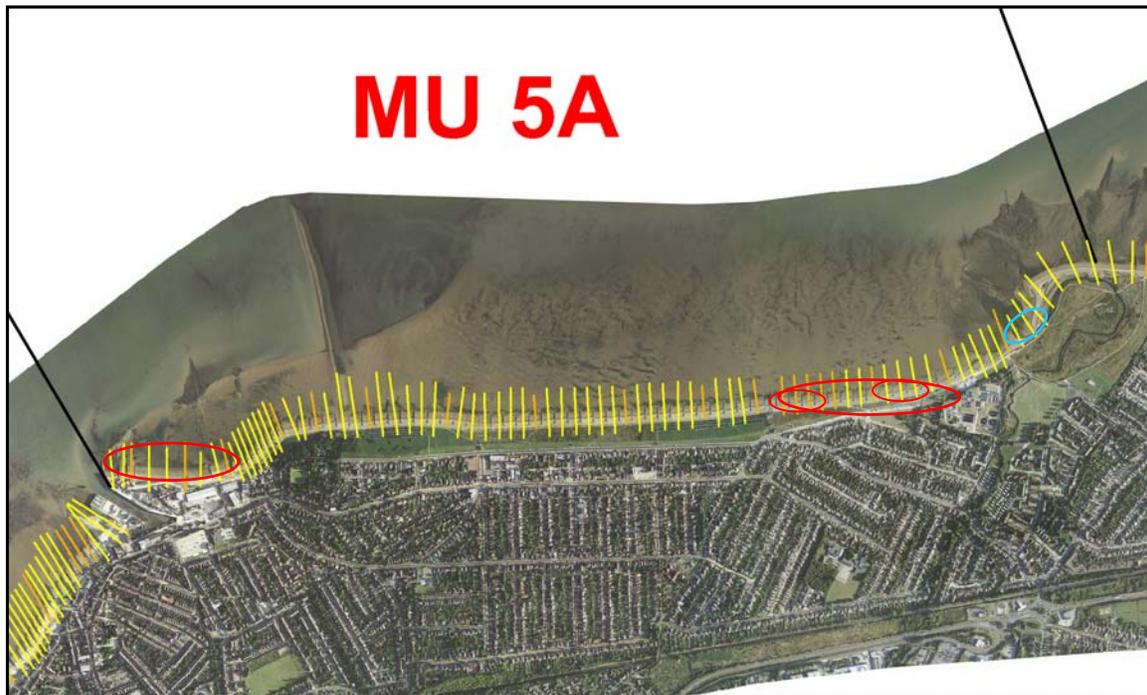
○ Blue: Recycling Extraction Point
○ Red: Recycling Deposition Area

The beach within this management unit is mixed shingle. The defences consist of a seawall, promenade and rear wave wall, fronted by timber groynes and a mixed shingle beach. The very eastern extent of the section however has no defences as the spit is consistently moving around the Swale Brook. To the west, the defences are backed by a steeply sloping grass bank. Protection of this management unit is vital to ensure the slopes do not fail as the current sea defences protect the slope toe. This area has previously been prone to landslides and has been defended to prevent such events, with the stabilization of the toe, Herring Bone drainage system and the aforementioned seawall and promenade. Within this management unit there is an offshore strip of shingle “The Street” which interferes with the natural flow of sediment to the west.

Recycling works are needed as the mouth of the Swalecliffe Brook regularly silts up, even more so in recent years than before; and the ever changing spit needs regular maintenance to allow a clear flow out of the Swalecliffe Brook. A capital replenishment scheme was undertaken towards the central and western sections in 2004 to replace groynes and increase beach volumes by 50,000m³.
