Figure 1: Management Unit 24 (Hastings)

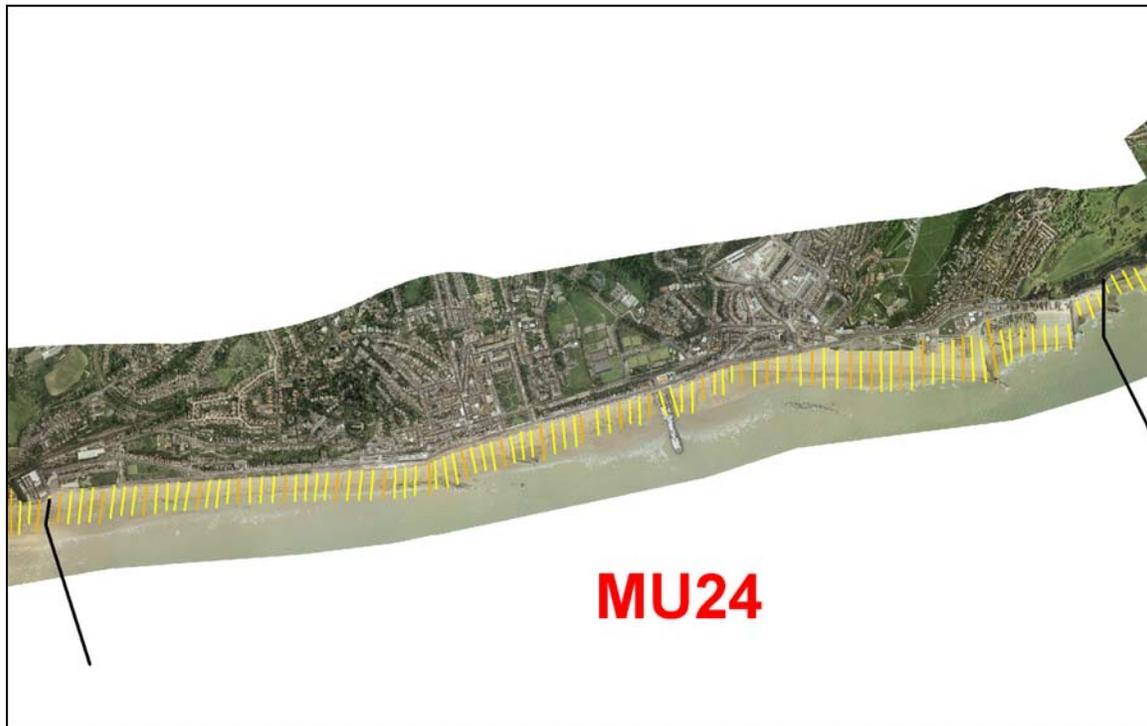
*Blue: Recycling Extraction Point*
Red: Recycling Deposition Area

The shingle beach at Hastings appears wide at high tide; however during low tide the beach exposes a sand foreshore. The beach hosts a seawall, promenade and groynes from Pelham Place Car Park west. The eastern section has a pocket beach, separated from the rest of the Management Unit by a concrete terminal structure, backed by a promenade. The beach is backed by sandstone cliffs along the majority of the frontage, which are easily erodible, providing a source of material to the beach. The town of Hastings is built on a series of low hills. The harbour arm is a key feature of this coastal landscape, acting as a main groyne retaining the beach in front of Carlisle Parade to the west. The structure also protects the harbour on the east side from the prevailing south westerly wave activity. The last maintenance works were conducted in the 1980s, and a new application for funding is currently underway for further maintenance in the forthcoming years.

Recycling events have been undertaken within this management unit in both 2009 and 2010. The 2009 works saw the maintenance and upgrading of the concrete terminal groyne structure at the east end of Rock-a-Nore Road, and the adjustment of planking on the three timber groynes between the pier and the main works site. The construction of a new rock groyne at Carlisle Parade; designed for easy ability to be raised when necessary. This section of coast is Hold the Line for the next 100 years (until Epoch 3).
