Figure 1: Management Unit 26 (Bexhill)

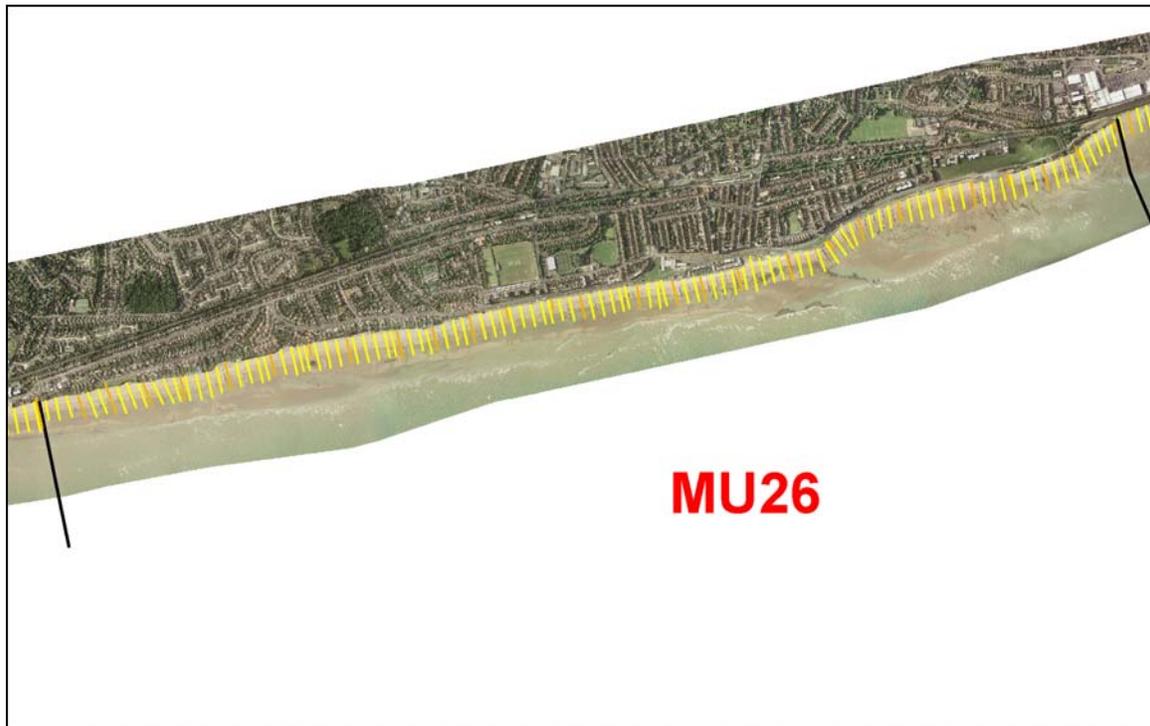
Blue: Recycling Extraction Point

Red: Recycling Deposition Area
