Figure 1: Management Unit 12 (Romney Sands)

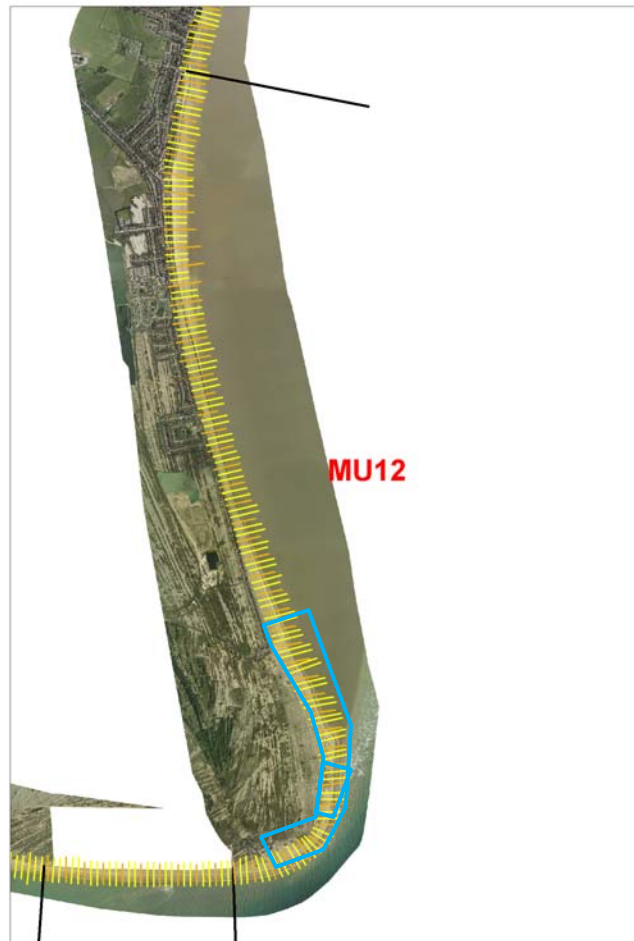
*Blue: Recycling Extraction Point*

*Red: Recycling Deposition Area*

Romney Sands is one of the only sections along the Kent coast which naturally accretes to such a high extent; the section around the peninsula is particularly accretive and requires a regular extraction of material, which are usually deposited at Camber Sands. The beach material is split into components. The northern extent has a large shingle ridge which protects the housing area close to the shoreline. Further south is an extensive set of sand dunes, which are known to be accreting. Even further south is the shingle beach face, characterised by the large shingle ridge, and a mixed shingle sand slope and sand foreshore.
