**Figure 1: Management Unit 29 (Eastbourne)**

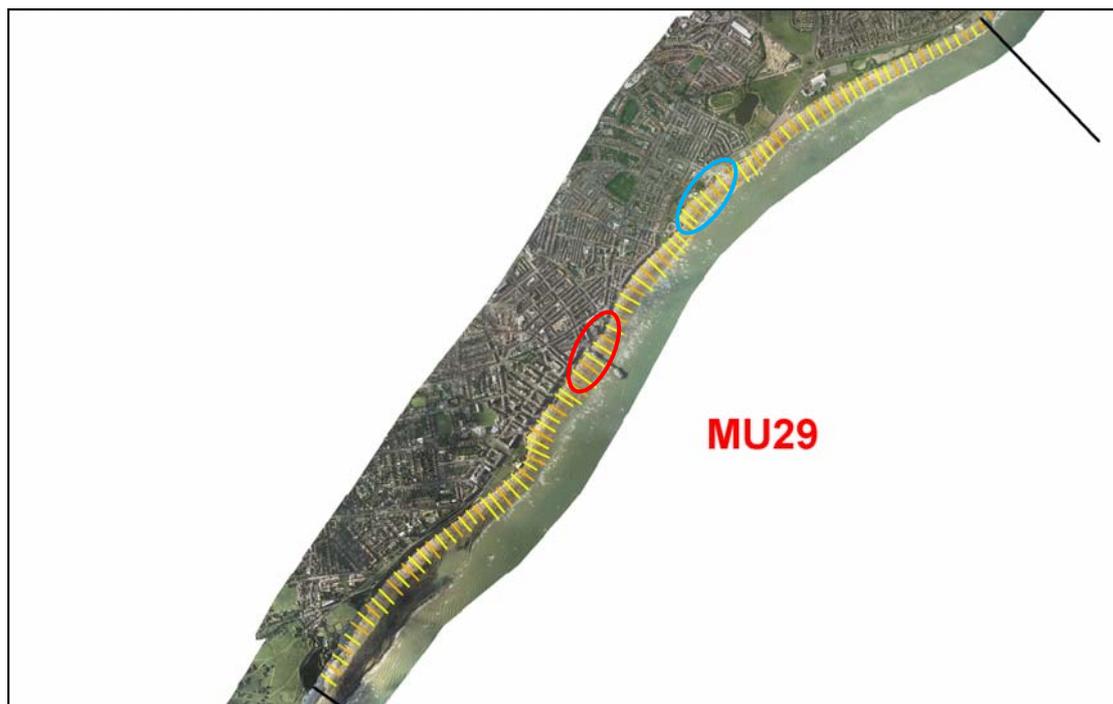
○ Blue: Recycling Extraction Point  
○ Red: Recycling Deposition Area

Recycling works have been undertaken in 2006 and 2009. During the latter scheme, excess material from seven groyne bays to the east of the town centre, and a further stockpile of shingle near Langney Point in MU28 (Sovereign Harbour), was extracted and used to renourish seven groyne bays in the vicinity of Eastbourne Pier in the centre of the management unit.
